CCR Rule Compliance Report Summary

Mercer Generating Station, Hamilton Township, New Jersey

April 17, 2018
Project 1504710

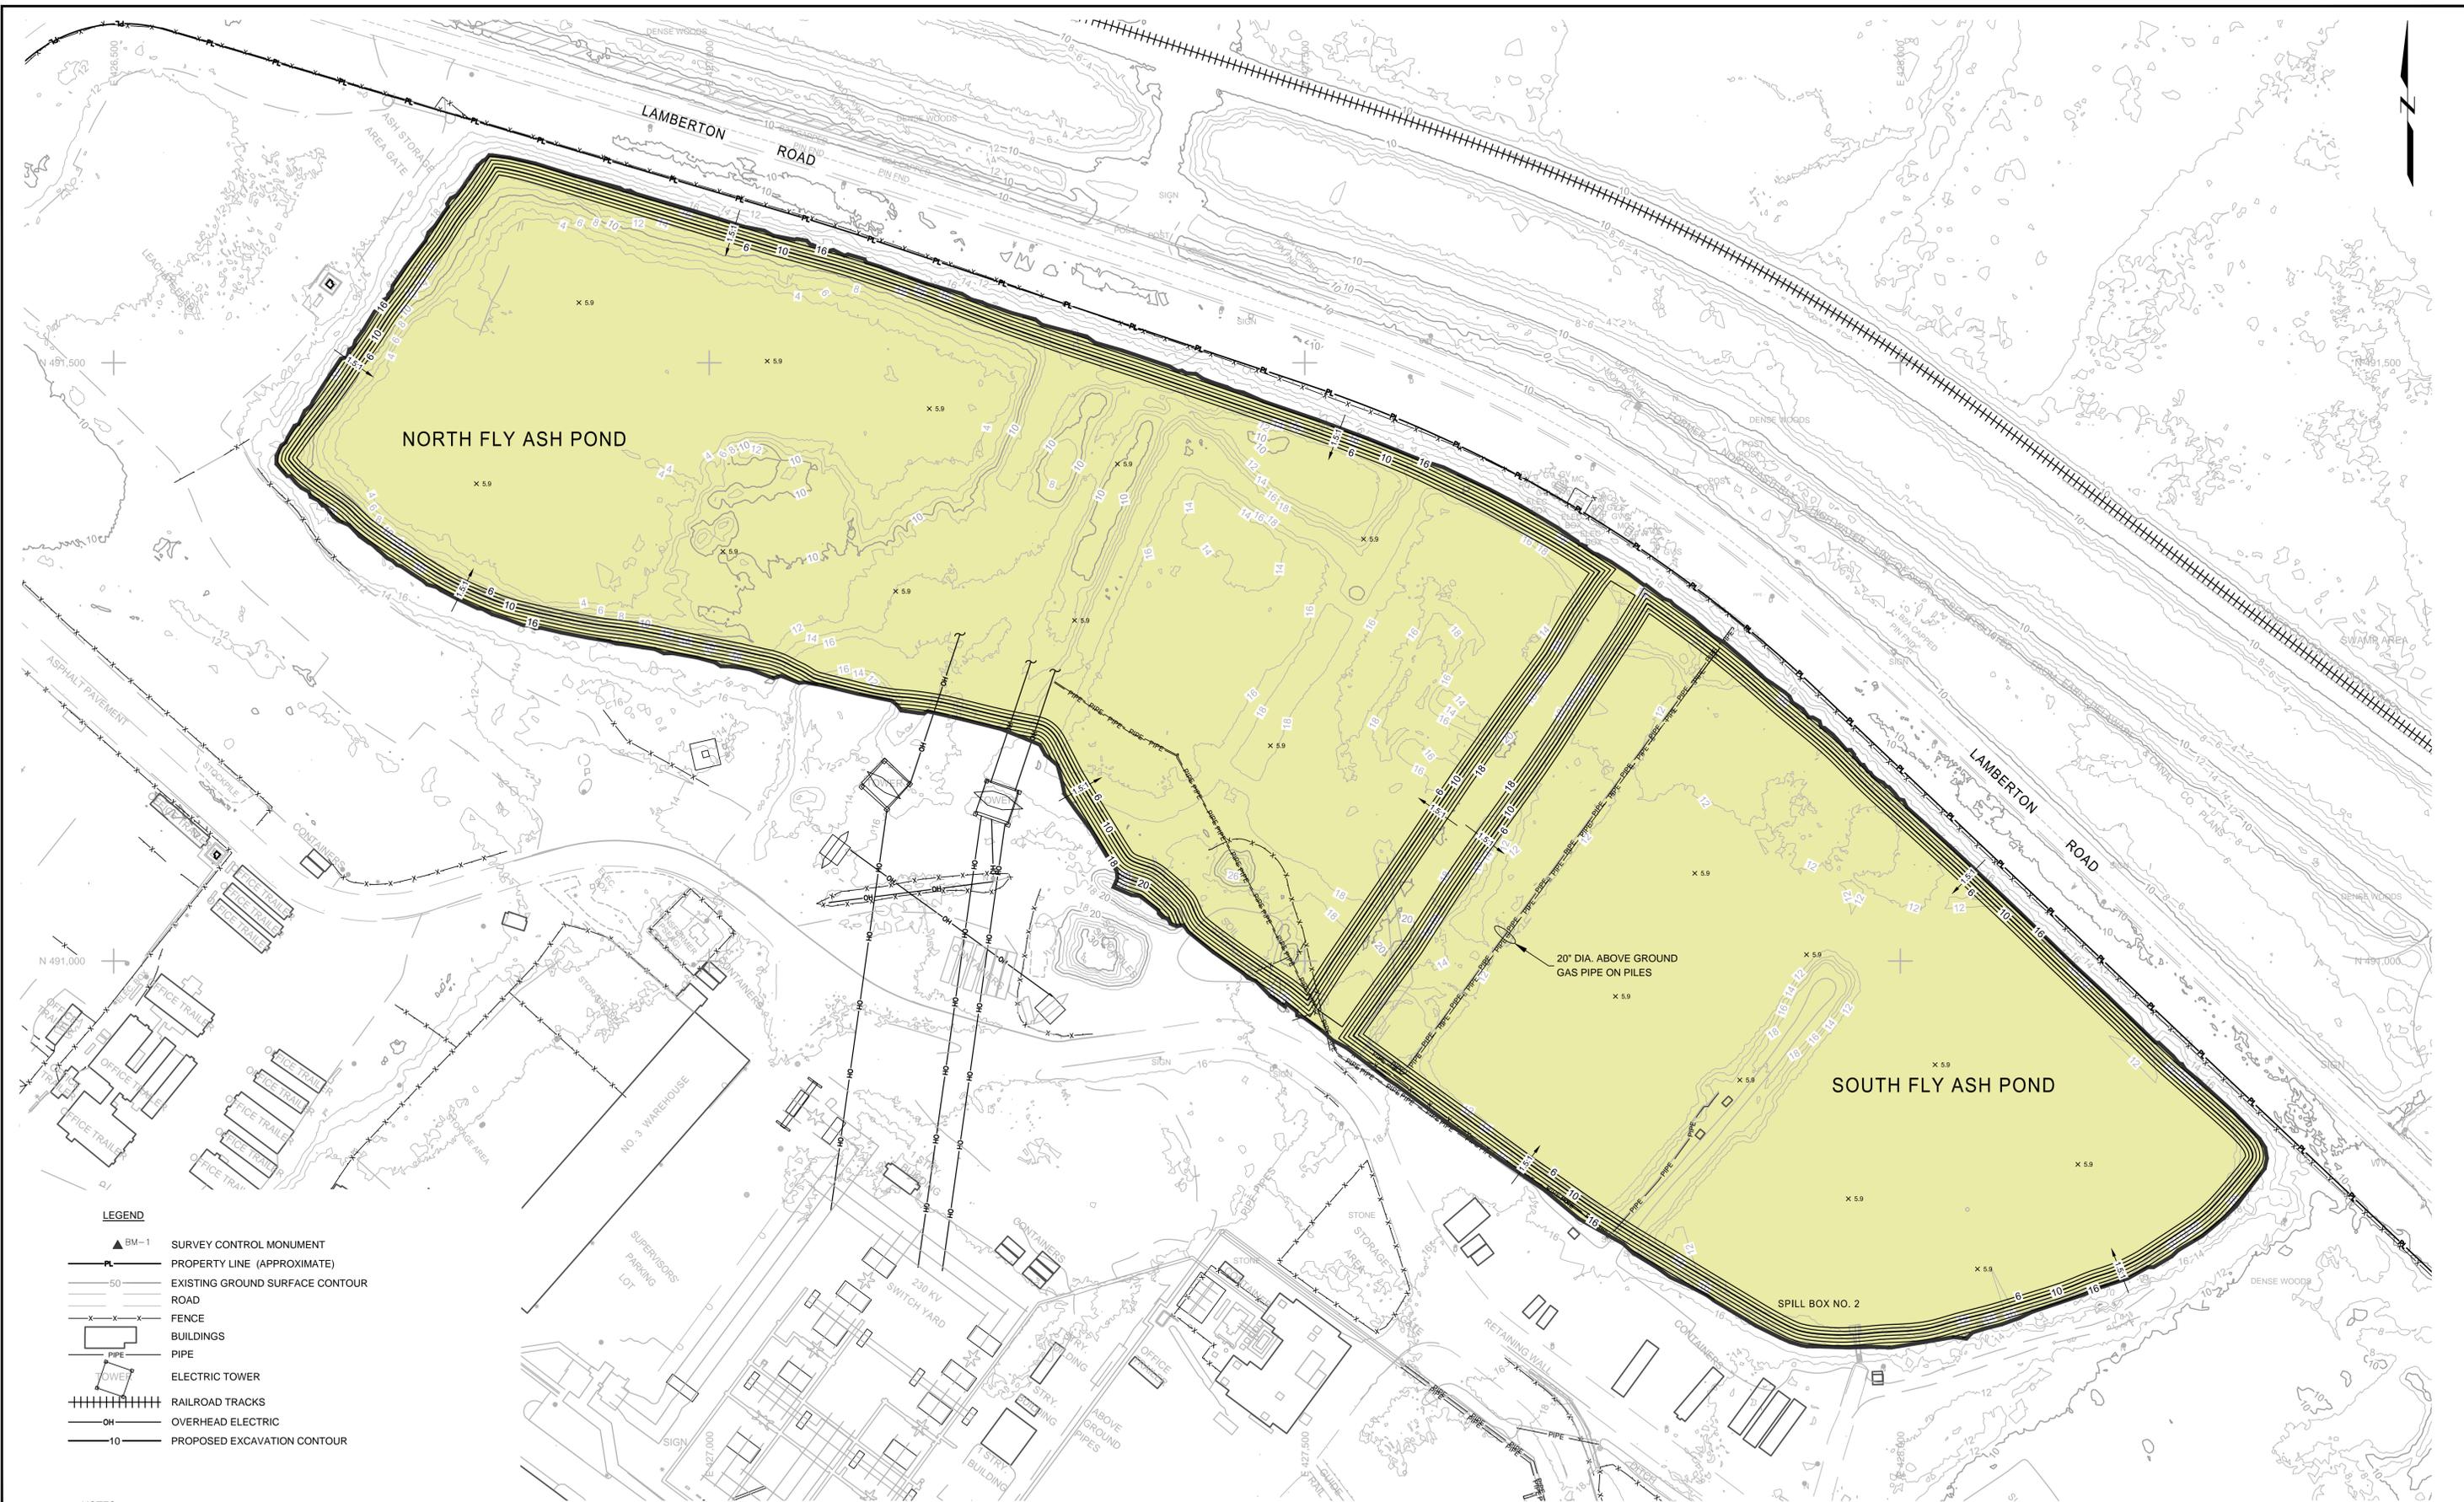
Project 1504710 April 2018 Fig. 2

CCR IMPOUNDMENT
FOOTPRINT AND INITIAL
CONDITIONS PLAN - NORTH
AND SOUTH FLY ASH PONDS

Figure 2 shows the initial inactive CCR unit layout. **Figure 3** shows the CCR impoundment removal area.

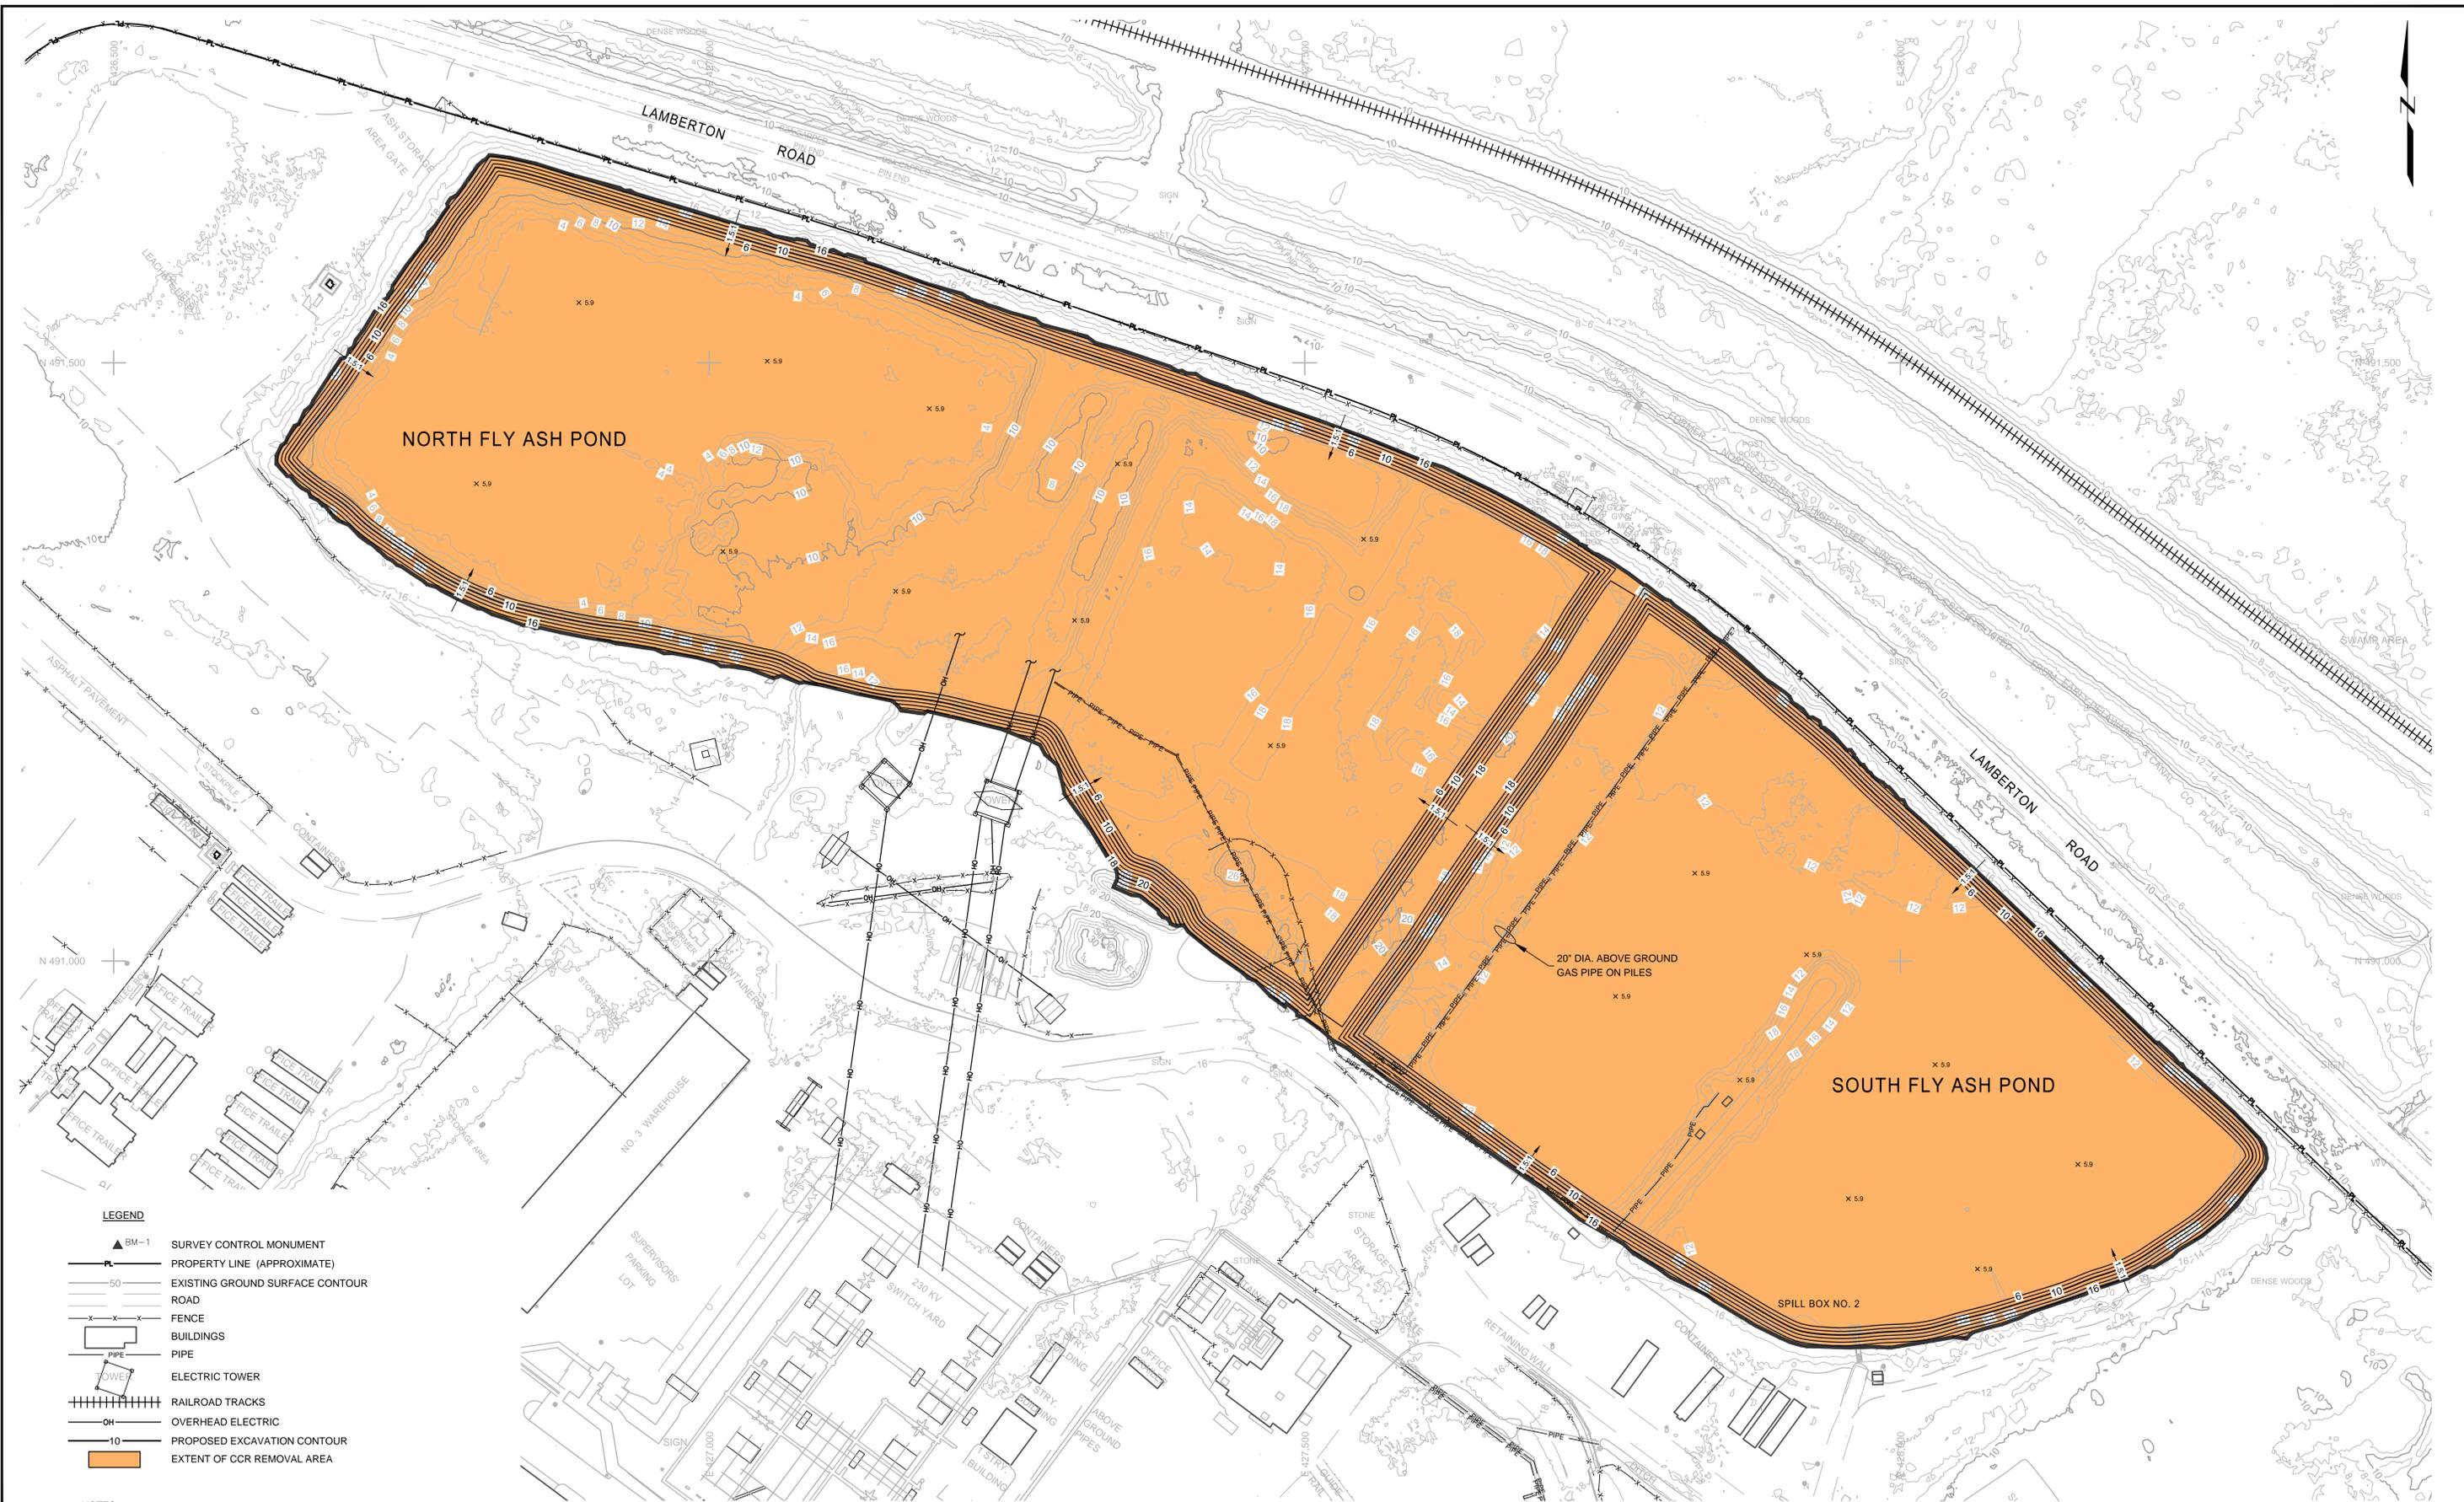
Project 1504710 April 2018 Fig. 3

CCR IMPOUNDMENT
 FOOTPRINT AND REMOVAL
 AREA - NORTH AND SOUTH FLY
 ASH PONDS
